The Willow Creek Gazette

Willow Creek Railroad Museum

Winter 2017

Signaling the Double Crossover

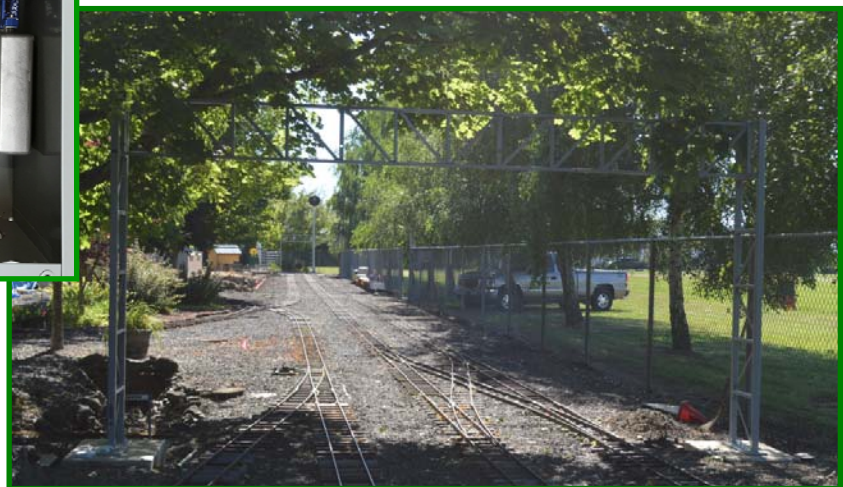
Showing location of signal bridge that will indicate position of switches for Double Crossover

The Double-Crossover system will consist of a motor to drive each of the four turnouts and loop detectors to prevent operation of the turnouts when a train is present. The turnouts will be controlled by pushbuttons. A signal will be located above each mainline on the signal bridge. An indicator will also be located on the signal bridge between the mainlines to display crossover positions “X” or “||”.

When the turnouts are lined in their typical “X” position, incoming trains on the two mainline tracks will be permitted through the crossover on a “first-come” basis similar to how the 3-way crossing currently operates. When the turnouts are lined “||” straight through, each mainline will operate independently.

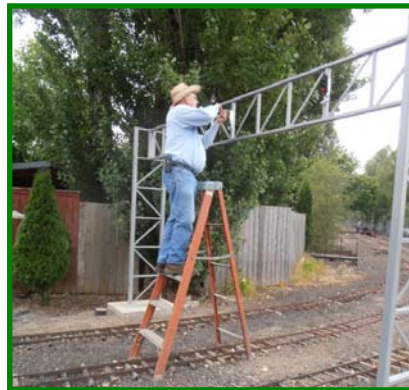
July 1st

Alan installs signal head on new bridge.

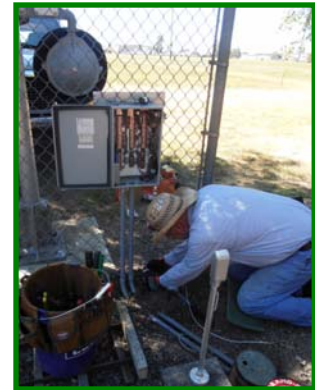
July 22nd

Alan installs electronics and detectors to activate crossing signal outside the south gate.

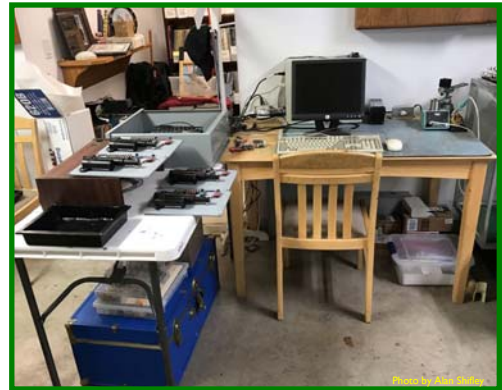
October 7th

Alan's ICP work station for future south side electric switch controllers.

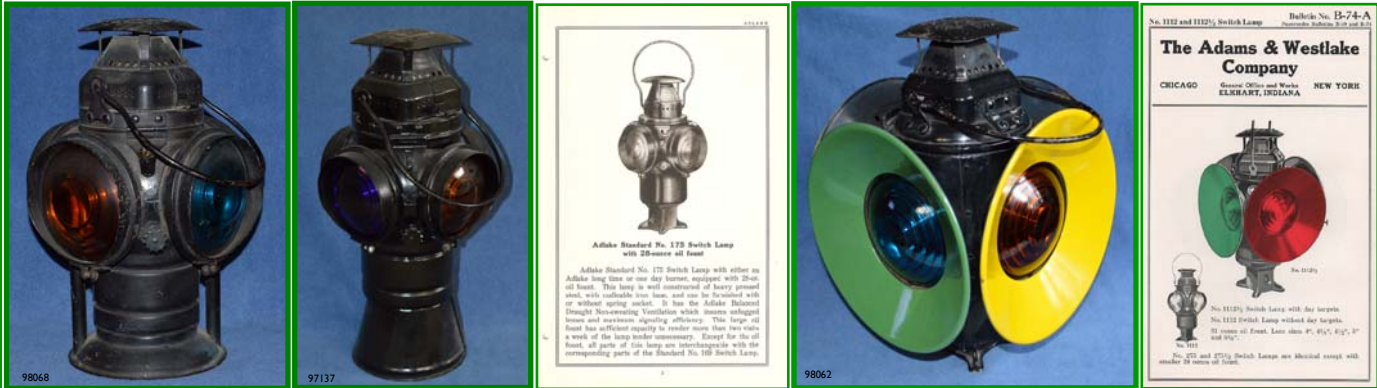
Railroad lamps are distinguished from lanterns by both function and design. Lamps were generally intended to be stationary, were generally made of a sheet metal or cast metal body, and used lenses to amplify light from an interior light source. A wide variety of different lamps were used by the railroads, including semaphore lamps, classification lamps, train order lamps, bridge lamps, marker lamps, and switch lamps. Lanterns were designed to be portable and used globes which were surrounded by a metal frame. This article will discuss switch lamps. Their purpose was to make switch alignment readily visible.

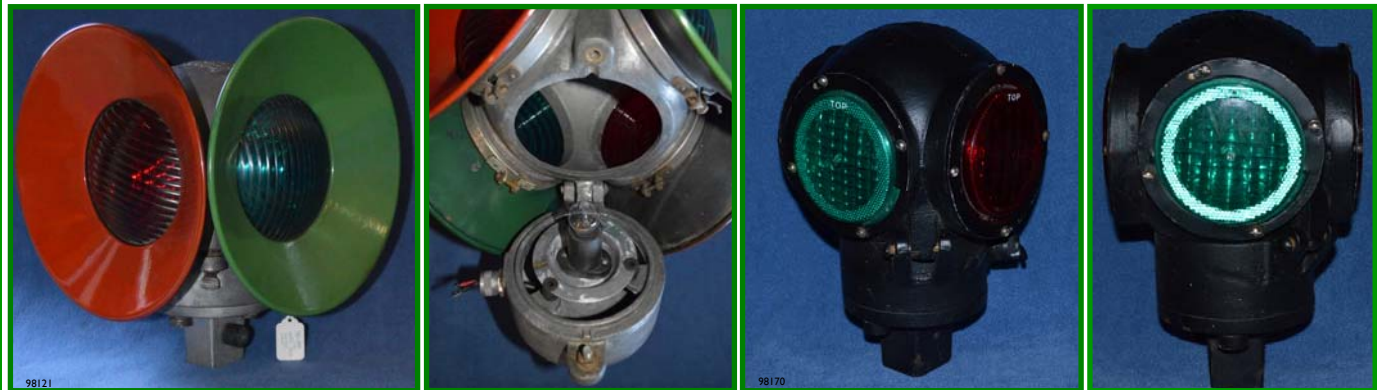
To further reduce cost railroads eventually switched to electrically illuminated lamps to eliminate oil lamp maintenance. The lamp on the right is electrically illuminated with an additional feature. The plastic lens is faceted around the perimeter. Reflection from headlights can illuminate this signal. This made the signal visible in the event the bulb burned out.

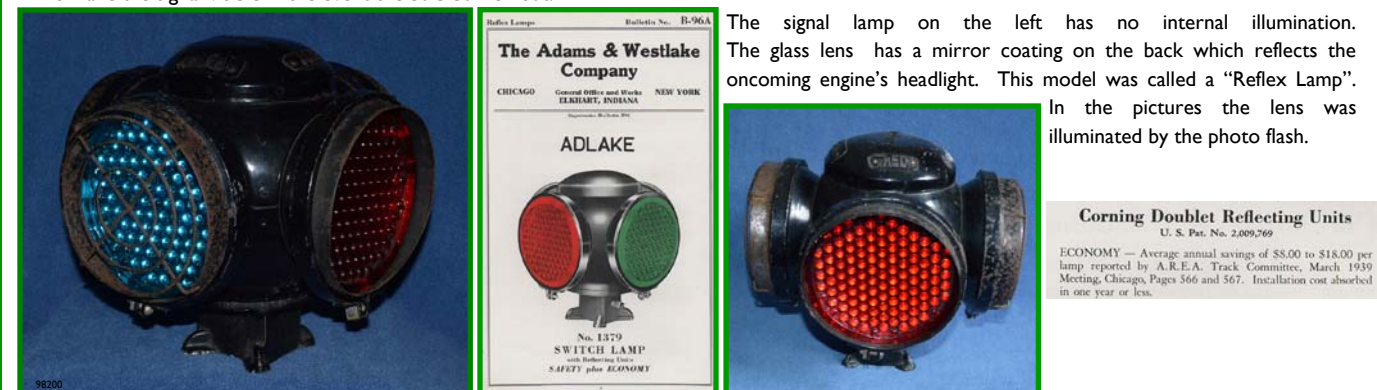
Corning Doublet Reflecting Units
U. S. Pat. No. 2,009,769

ECONOMY — Average annual savings of \$8.00 to \$18.00 per lamp reported by A.R.E.A. Track Committee, March, 1939 Meeting, Chicago, Pages 566 and 567. Installation cost absorbed in one year or less.
